FIELD SERVICE BULLETIN #008

Where Used: All plotters/imagesetters

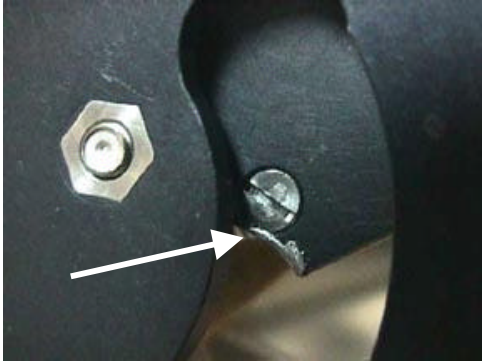
Fig. 1

Problem: Excessive wear (metallic powder/metal particles) due to the cam followers of the latching operation coming in contact with the top front frame during opening and closing of the upper chassis.

- ∑ Locate problem area and look for signs of excessive wear. (See Fig. 1)
- ∑ If re-adjustment is needed, remove both end covers.
- ∑ Measure from the front edge of the chassis frame to the front of the cam follower. (See Fig. 2) The location of the cam follower from the factory is all the way towards front of plotter, approximately 7/16".
- ∑ Loosen the cam follower using a 3/8 nut driver on the hardware located on the outside of the chassis frame, (See Fig. 3) and a screwdriver holding the body of the cam follower.
- ∑ Relocate the cam follower 1/16" towards the rear of the plotter and tighten hardware.
- ∑ When the cam follower is in the correct position, the front edge of the latch will be approximately parallel with the front edge of the chassis frame and the latch knob approximately 1/16"-1/8" away from the knife stiffener. (See Fig. 4 and 5)
