FIELD SERVICE BULLETIN #002

Where Used: GS 642 Paper Take Up P/N 644-103936

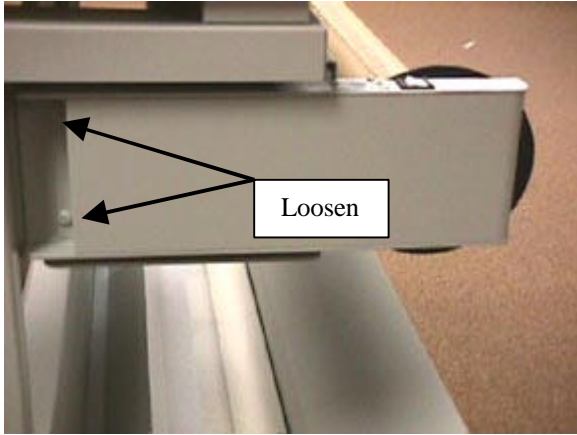
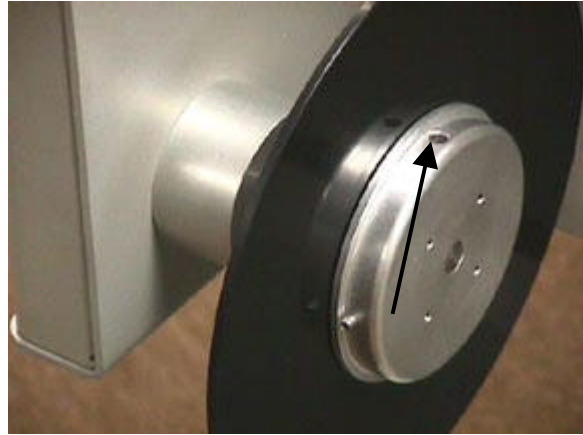
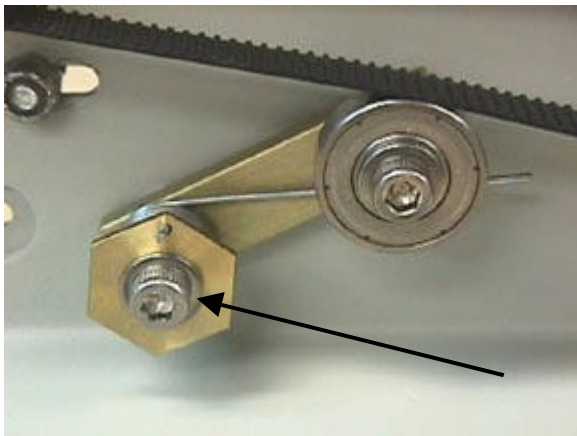
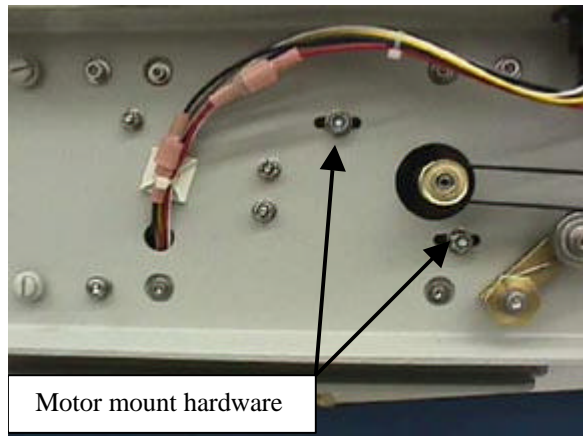
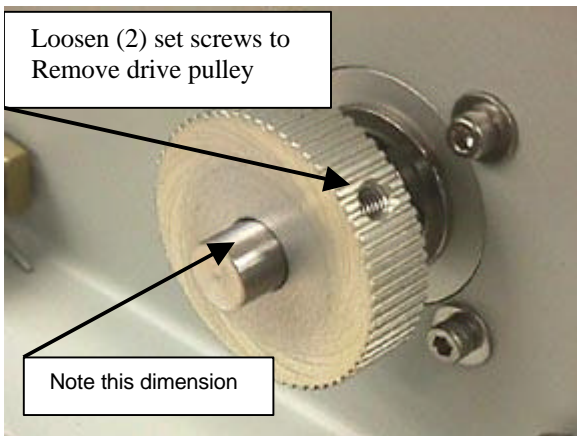
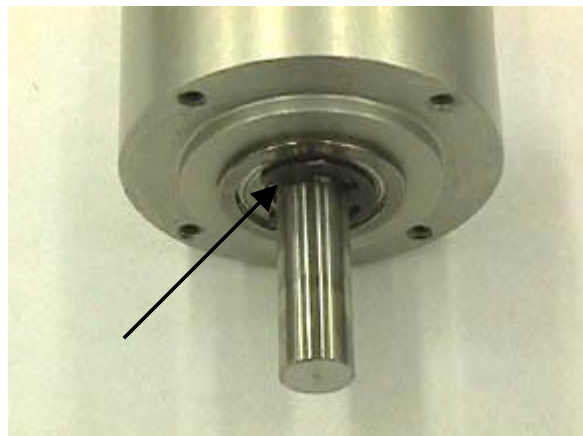
See next page for illustrations.

Problem: Left side flange hub assembly is not aligned with the path of media/film.

Solution: Install longer drive shaft (P/N 644-104573) Order: Modification Kit 644-104579

- ∑ Remove the left side cover from Paper Take Up.
- ∑ Remove media core.
- ∑ Remove left side flange hub assembly.
- ∑ Loosen the belt tensioner assembly screw.

- ∑ Slightly loosen the motor mounting hardware and relieve the belt tension and remove the belt.
- ∑ Remove the drive pulley. (*Note* position of the pulley on the shaft)

- ∑ Remove the E-clip rings, spacers and bearings that hold the drive shaft into the drive shaft hub. (*Note* the position of the shaft in the drive shaft hub)
Replace the shaft with the new shaft. (longer one) It may be easier to remove the drive shaft hub assembly to change out the shaft.

- ∑ Replace the E-clips, spacers and bearings. There are additional spacers in the modification kit if the shaft has excessive lateral movement after being installed.

- ∑ Replace the drive shaft hub assembly if it was removed.
- ∑ Replace the left side flange hub assembly, flush to the end of the shaft.
- ∑ Replace the drive pulley back to its original position.

- ∑ Replace belt. Slide the motor towards the rear of the paper take up to create tension for the belt. DO NOT OVER TIGHTEN THE BELT The belt does not have to be overly tight, just snug.

- ∑ Rotate the Arm Pivot of the belt tensioner assembly 90° of a turn counter-clock-wise. Hold the arm pivot in this position while tightening the mounting screw of the belt tensioner assembly. Bearing of the belt tensioner assembly should be in contact with the belt.
